Technical Report CERC-95-12
August 1995

Reef Breakwater Wave-Attenuation and Stability Tests, Burns Waterway Harbor, Indiana

Prepared for U.S. Army Engineer District, Chicago

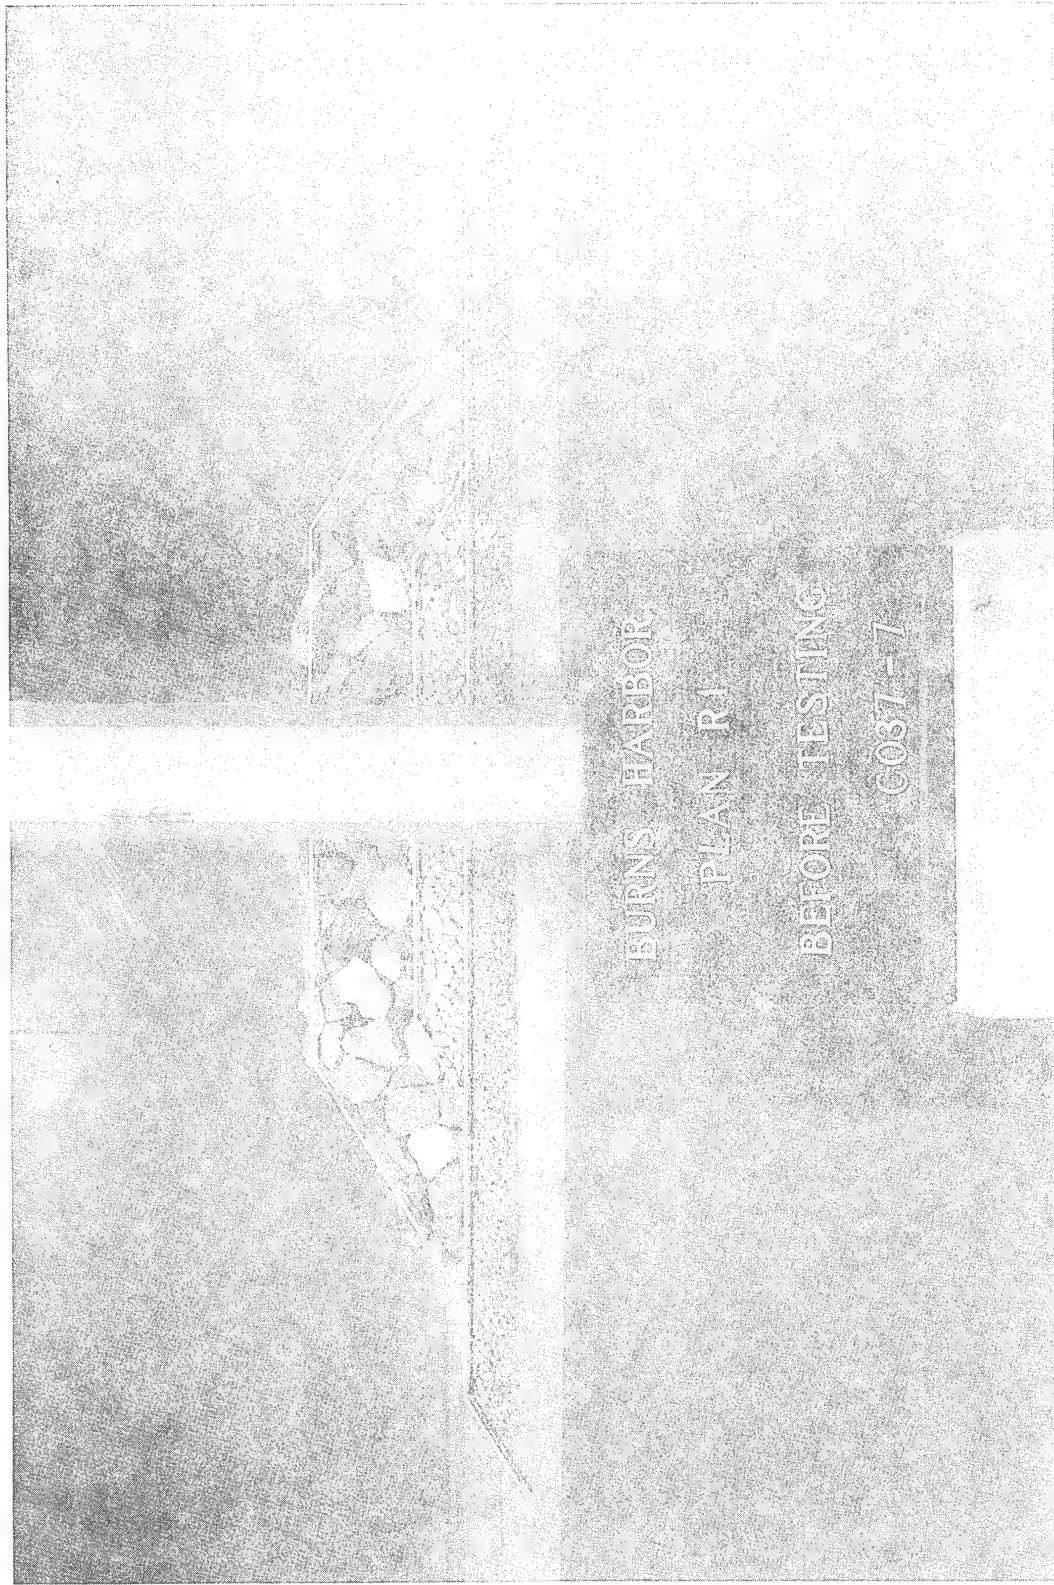
As shown in Figure 7, Plan R1 was successful in reducing 7- and 9-sec, 5-ft incident waves to heights of about 1 ft behind the breakwater. Also, as desired, transmitted wave heights of about 3 ft were observed for 11.6-sec, 13-ft incident waves. The reef was stable (Photo 2) and stability of the existing breakwater was significantly improved (Photo 3) relative to base conditions; however, a few armor stones were displaced.

Photo 1. End view of Plan R1 before wave attack

Photo 2. End view of Plan R1 after wave attack

Photo 3. End view of Plan R1 (reef and existing breakwater) after wave attack

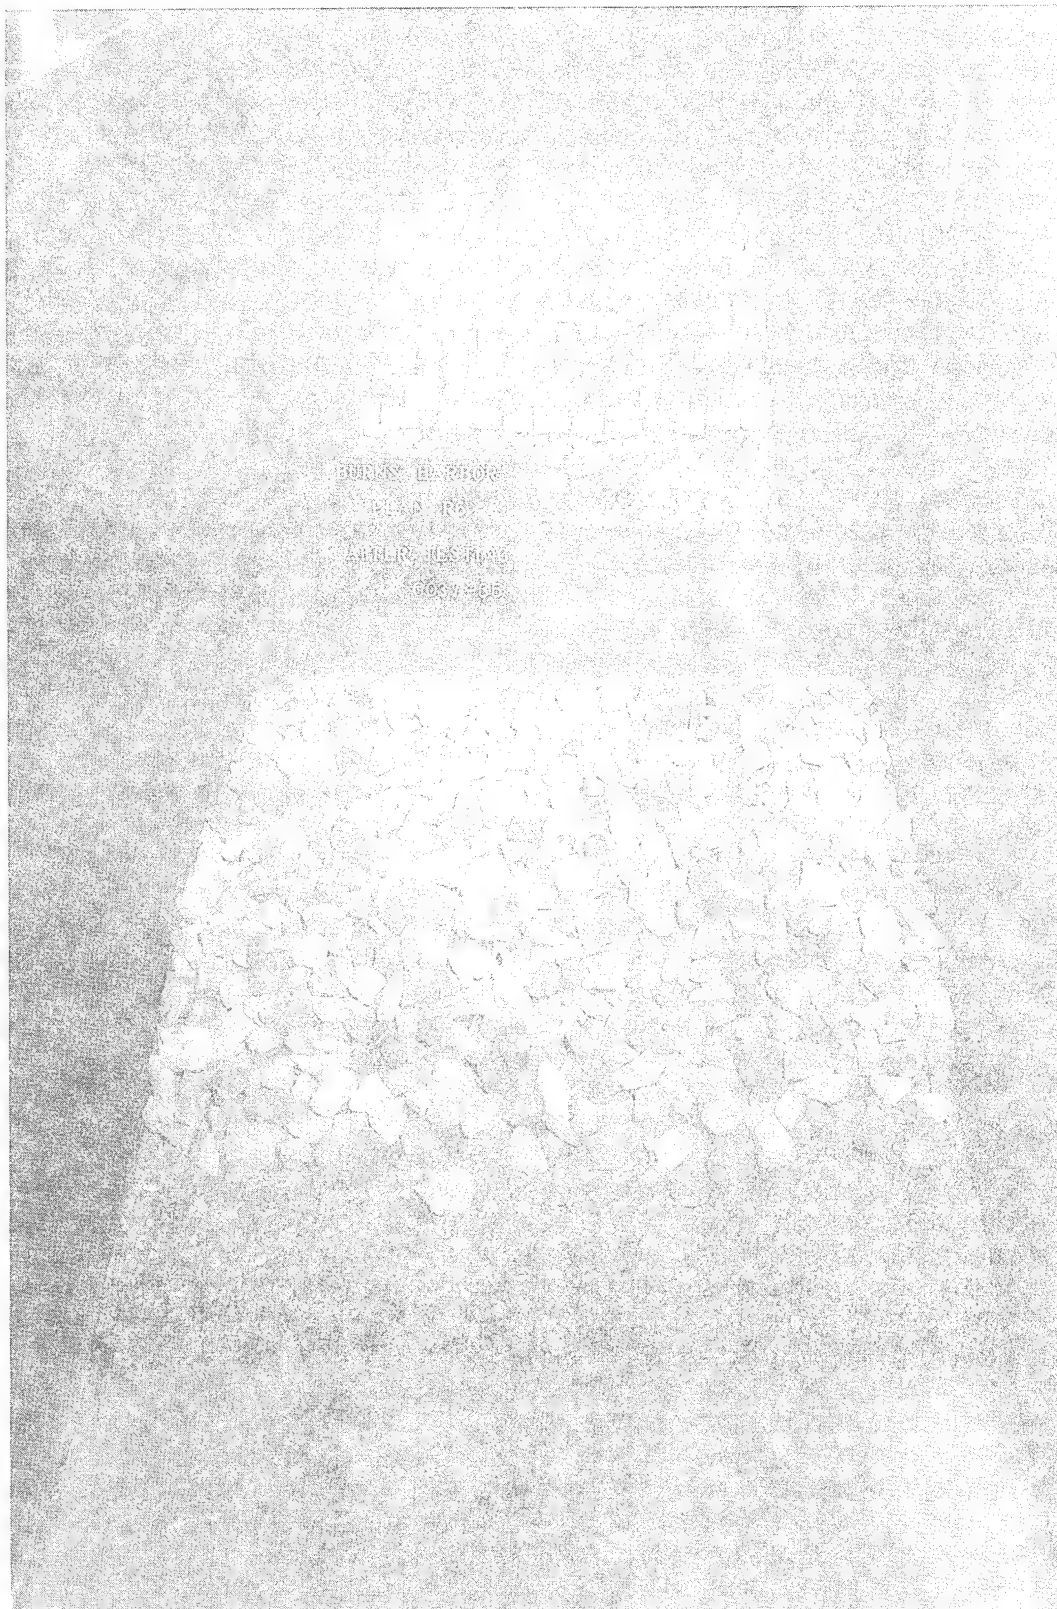
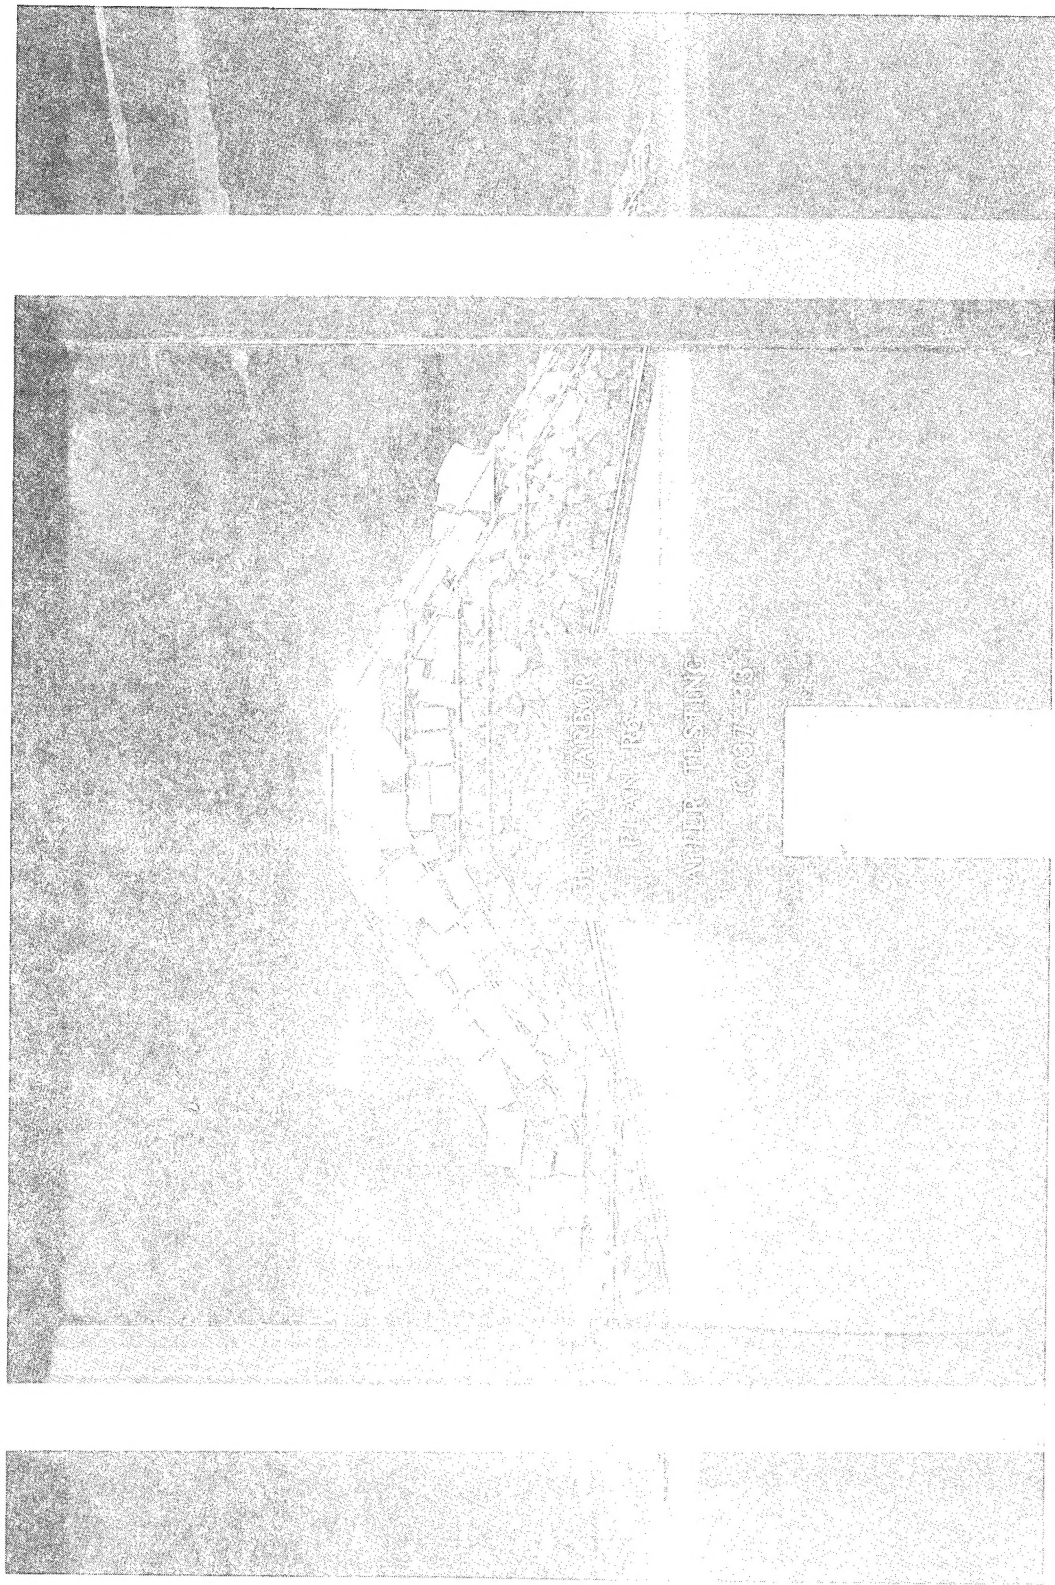
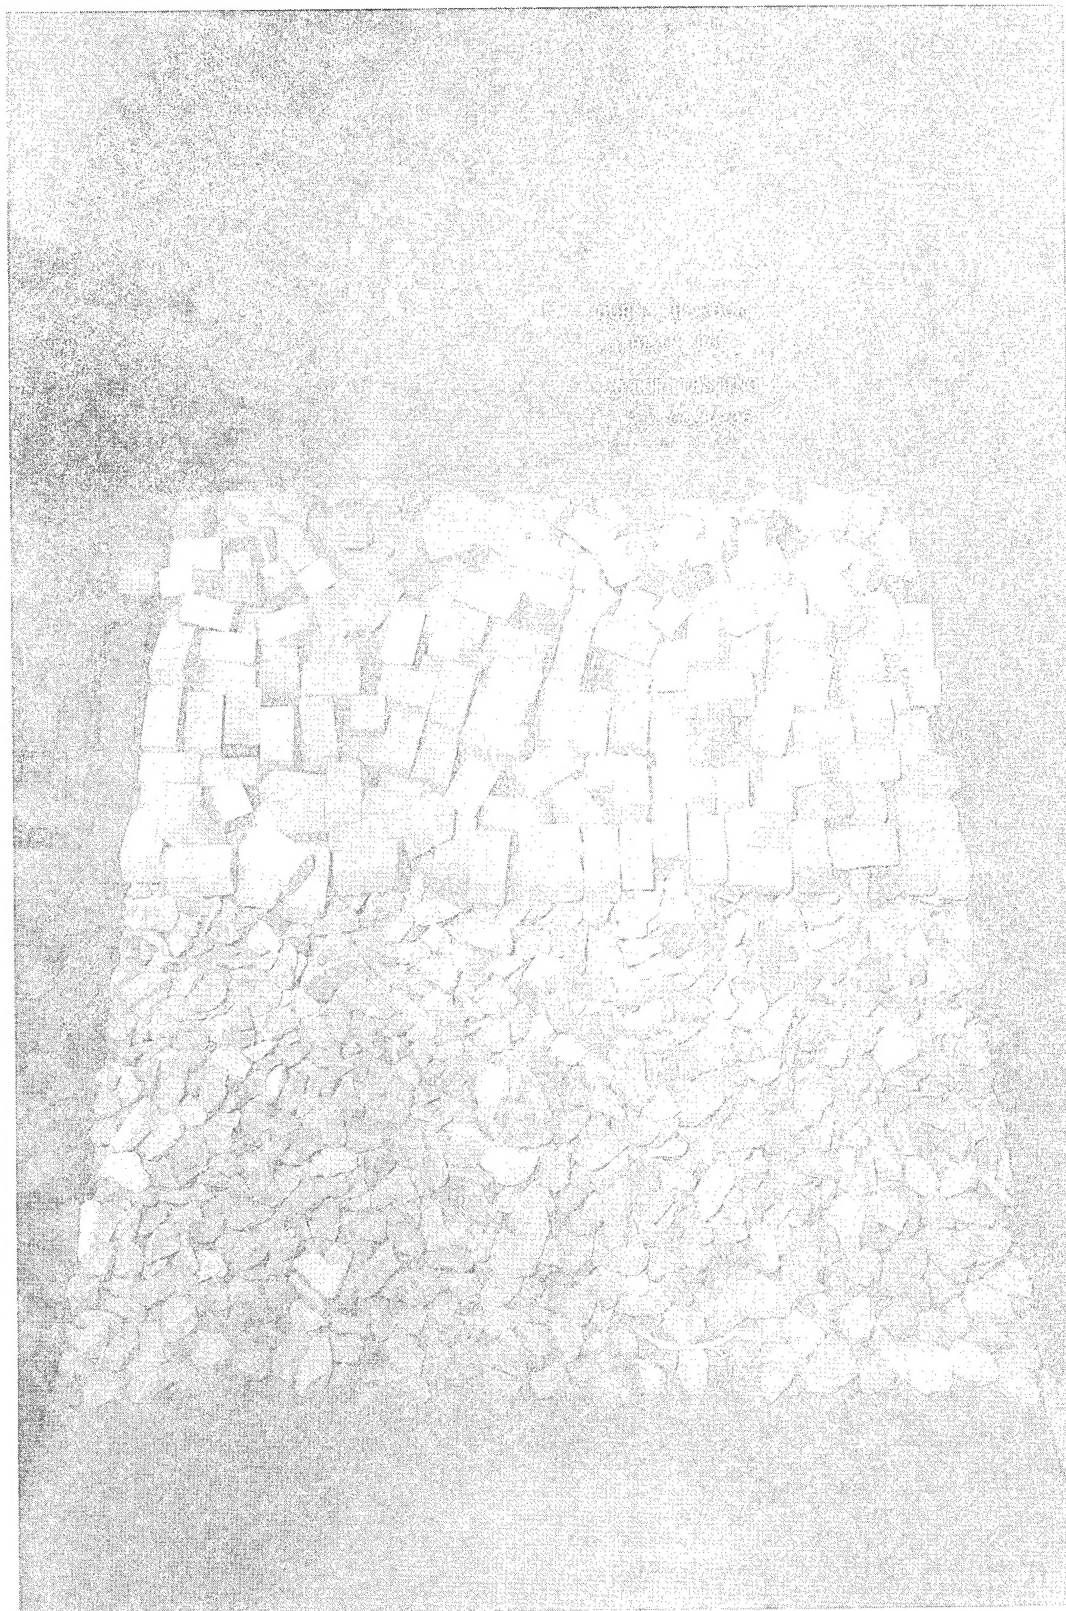
Plan R6 produced transmission results very similar to Plans R3 and R4 at the +4-ft swl. As expected and shown in Figures 18-20, consistently lower and higher transmitted heights were observed at the 0- and +6-ft swl's. Stability of the 1- to 5-ton stone used to armor the reef was very similar to Plans R4 and R5 and again considered acceptable with 4 to 5 percent of the original stone volume being displaced (Photos 17 and 18). One harbor-side armor unit was displaced from the existing breakwater (Photos 19 and 20).

Photo 17. Lakeside view of Plan R6 (existing breakwater in background) after wave attack

Photo 18. End view of Plan R6 after wave attack

Photo 19. End view of existing breakwater as protected by Plan R6

Photo 20. Harbor-side view of existing breakwater as protected by Plan R6
